The Fire Resistance Performance Of Five Specimens Of Wall Mounted Linear Gap Sealing Systems, When Tested In Accordance With BS EN 1366-4: 2006+A1: 2010

384919

Soudal (UK) Ltd

25th September 2017

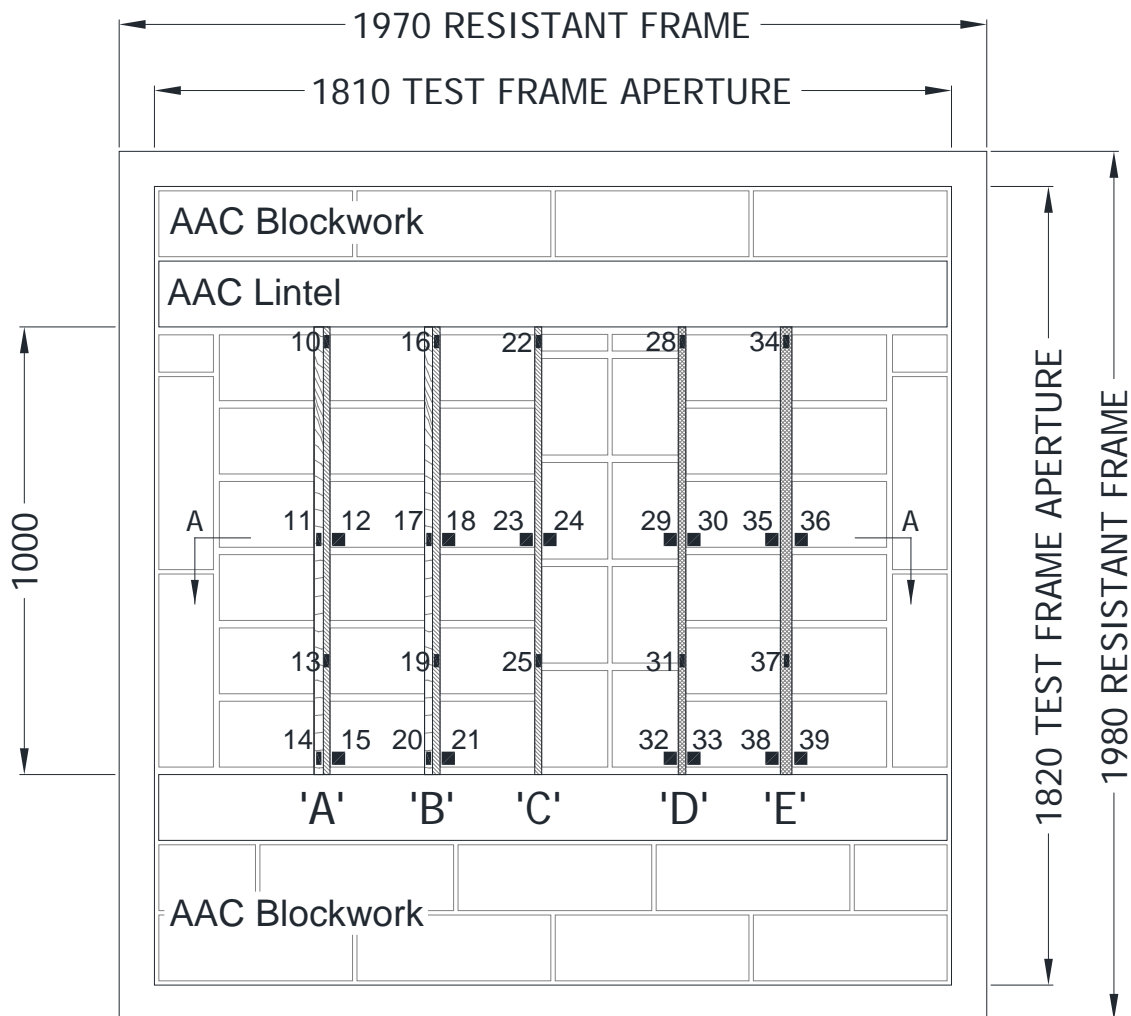
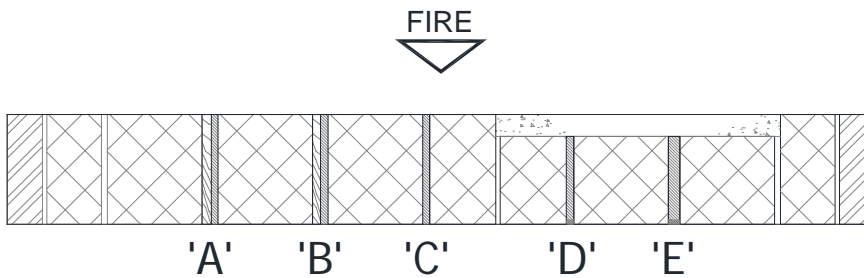
Figure 1- General Elevation of Floor Test Construction

GENERAL ELEVATION OF WALL SPECIMENS
'A' TO 'E' ON THE UNEXPOSED FACE

The section of wall had overall dimensions of 1500 mm high by 1500 mm wide by 250 mm thick for Specimens A to C, and 200 mm thick for Specimen D and E. The wall was made up of autoclaved aerated concrete blockwork arranged to provide five linear gaps of varying widths, each 1000 mm long.

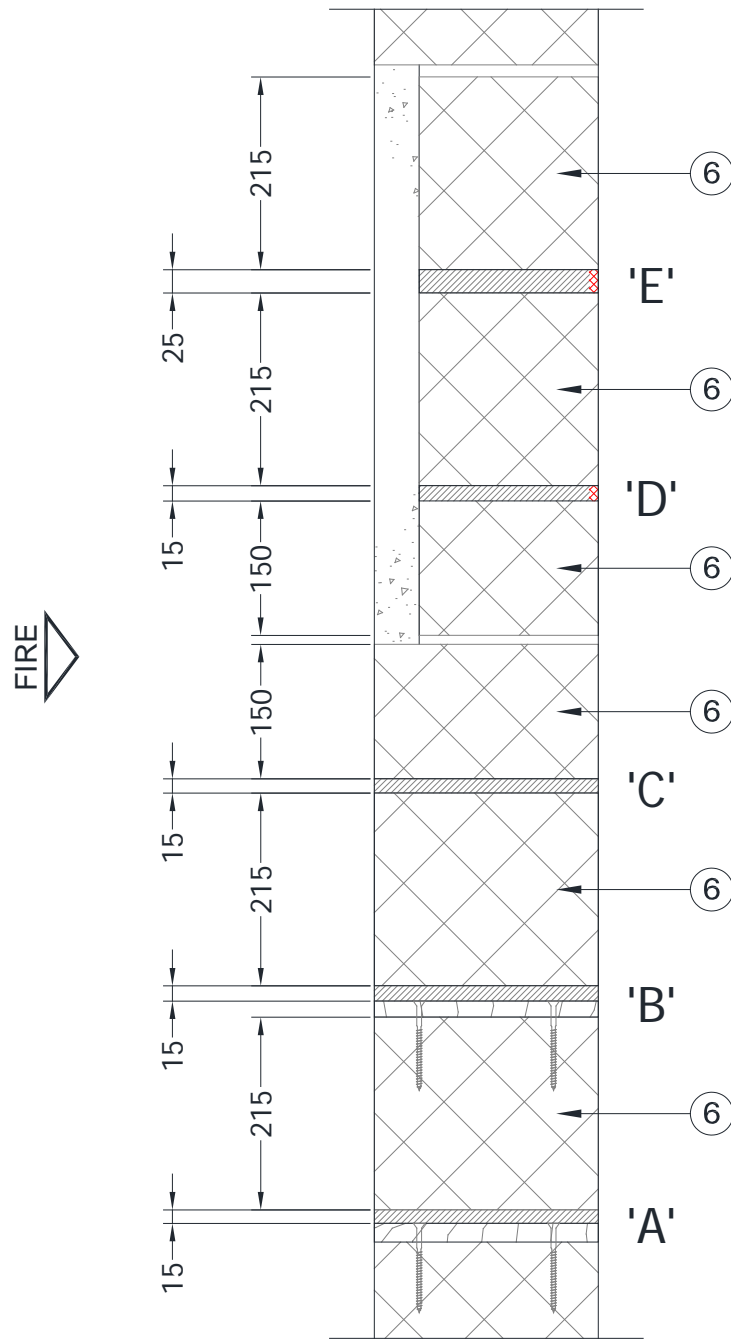
Figure 2 – Section Through A - A

SECTION A - A THROUGH WALL SPECIMENS A TO E

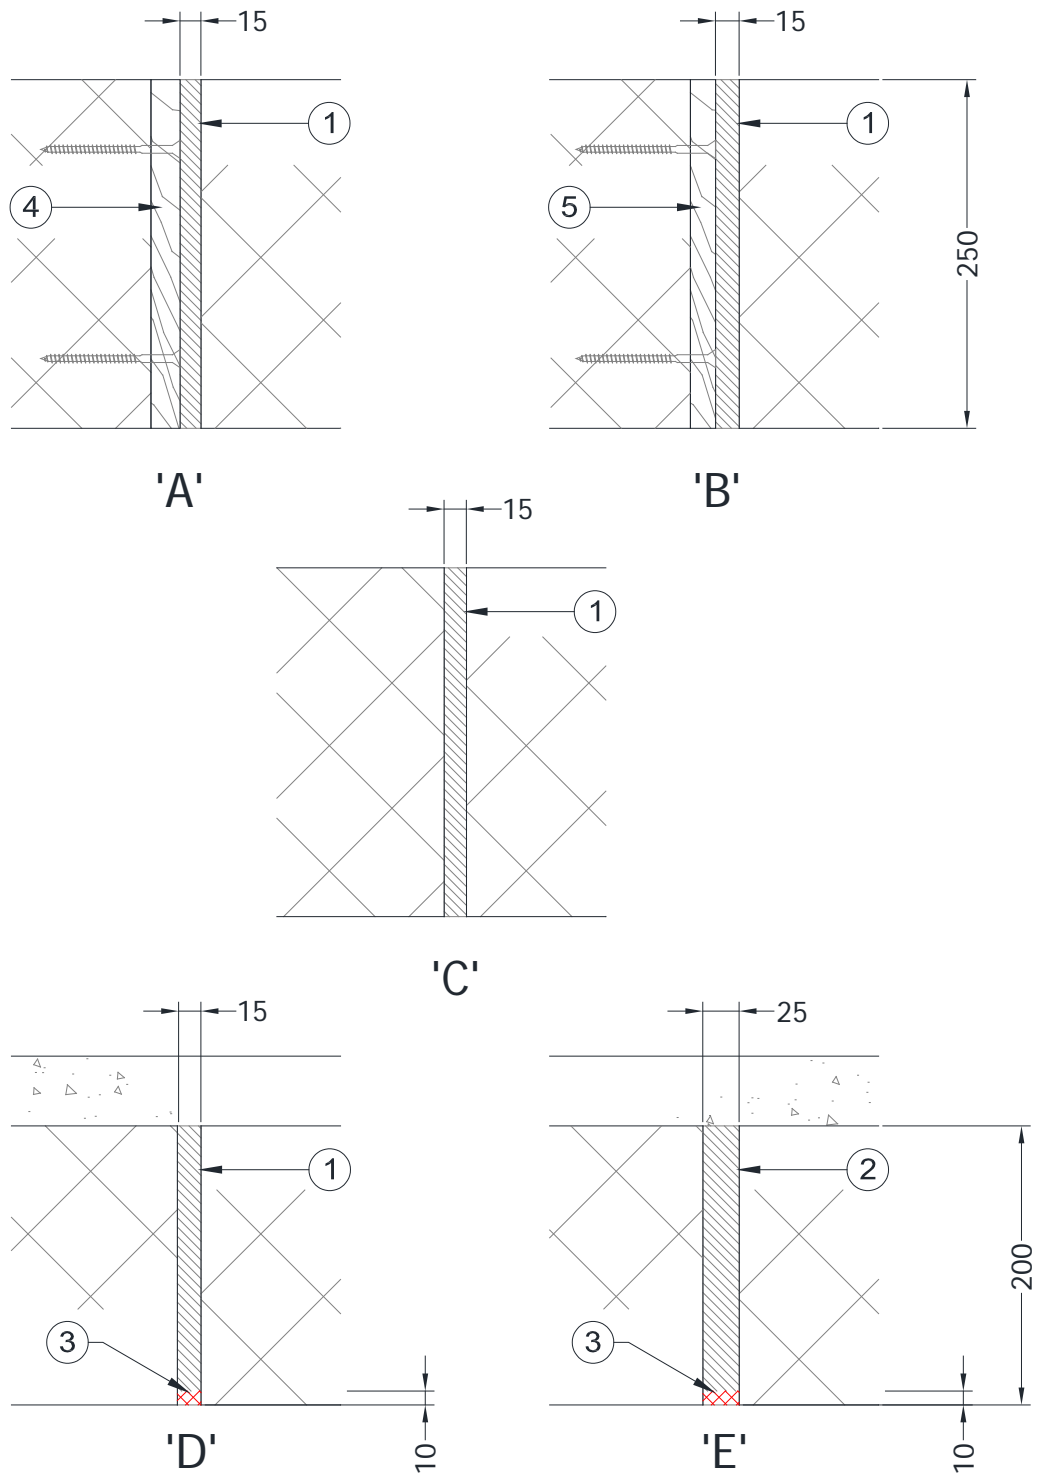
Figure 3 – Details of Wall Specimens A - E

DETAILS OF WALL SPECIMENS 'A' TO 'E'

Specimen	Gap width	Seal details
A	15 mm	The cavity incorporated a 21 mm thick hardwood, (species Sapele) gap facing. The cavity was sealed using a 250 mm depth of a can extruded polyurethane foam referenced "Soudafoam GUN B1"
B	15 mm	The cavity incorporated an 18 mm thick softwood, (species Pine) gap facing. The cavity was sealed using a 250 mm depth of a can extruded polyurethane foam referenced "Soudafoam GUN B1"
C	15 mm	The cavity in Aerated Concreted Substrate was sealed using a 250 mm depth of a can extruded polyurethane foam referenced "Soudafoam GUN B1"
D	15 mm	The cavity in Aerated Concreted Substrate was sealed using a 190 mm depth of a can extruded polyurethane foam referenced "Soudafoam GUN B1". A 10 mm depth of acrylic based sealant referenced "FIRECRYL FR" was applied to the unexposed face of the cavity
E	25 mm	The cavity in Aerated Concreted Substrate was sealed using a 190 mm depth of a can extruded polyurethane foam referenced "Soudafoam FR". A 10 mm depth of acrylic based sealant referenced "FIRECRYL FR" was applied to the unexposed face of the cavity

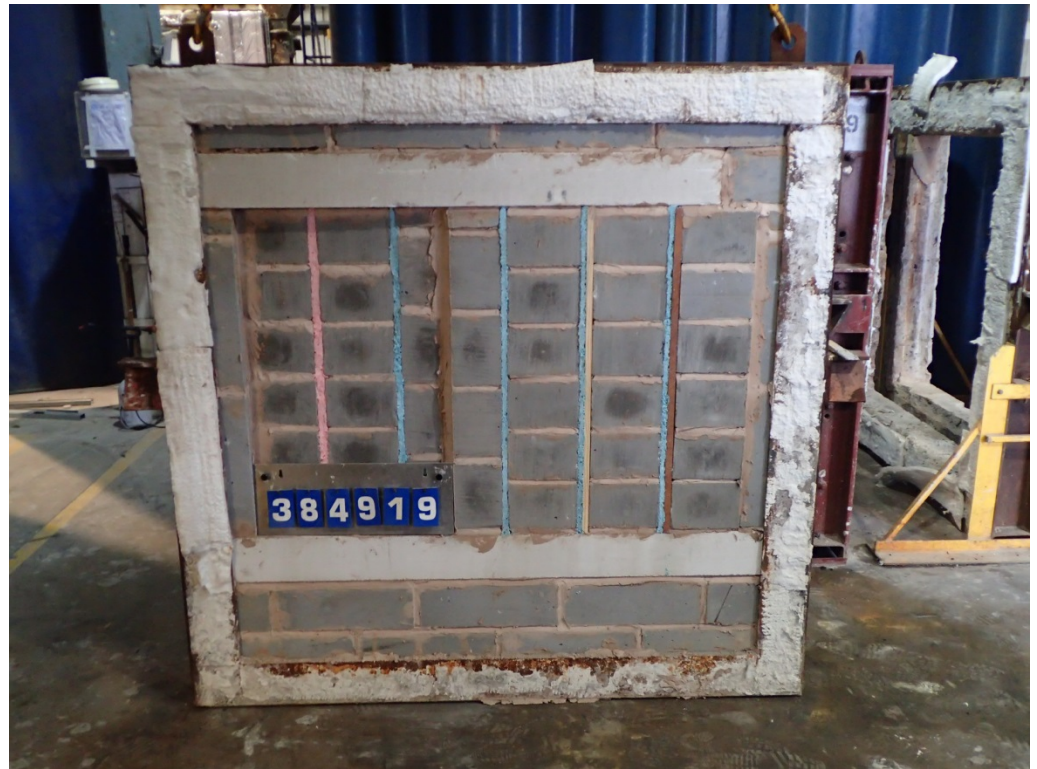
The exposed face of the wall construction prior to testing

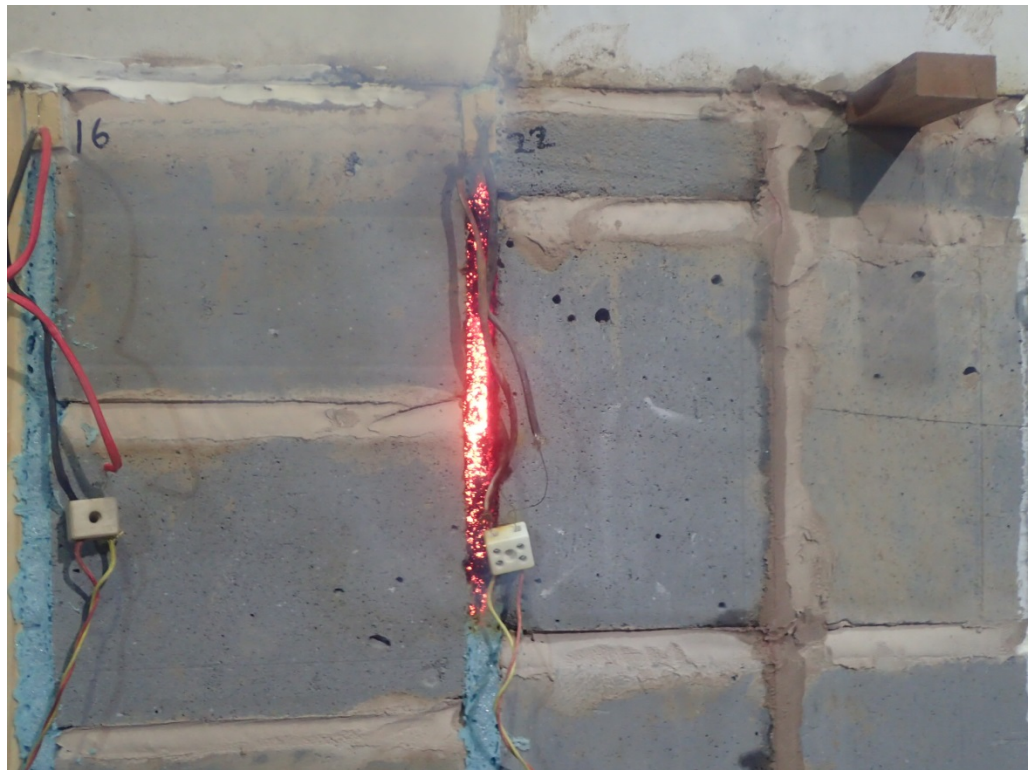
**Burn through seen
at the head of
Specimen C after
a test duration of
156 minutes**

150	00	No significant visible change. All specimens maintain integrity and insulation allowing the test to continue.
156	00	Burn through specimen C at approximately 50mm down from the head to approximately 100mm above the approximate middle. Sustained flaming occurs. Integrity and insulation failure is deemed to have occurred.
158	00	Specimen C is blanked off to allow the test to continue.
174	17	Through gap forms above mid-height of specimen A.
175	35	Cotton wool pad applied. Cotton wool pad discolours but fails to ignite.
177	42	Cotton wool pad reapplied on specimen A. Cotton wool pad discolours but fails to ignite.
179	11	Cotton wool pad reapplied on specimen A. Cotton wool pad discolours but fails to ignite.
179	34	Sustained flaming occurs on Specimen A.
180	51	Specimen A is blanked off to allow the test to continue.

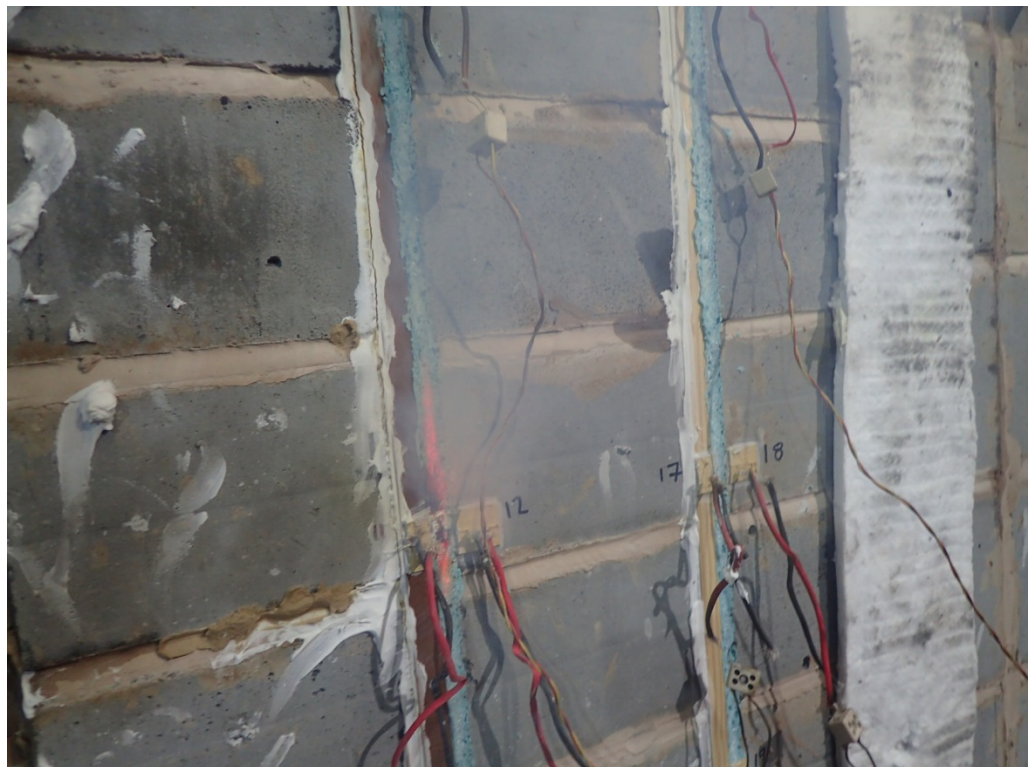
**Integrity failure
seen from
Specimen A after
a test duration of
179 minutes**

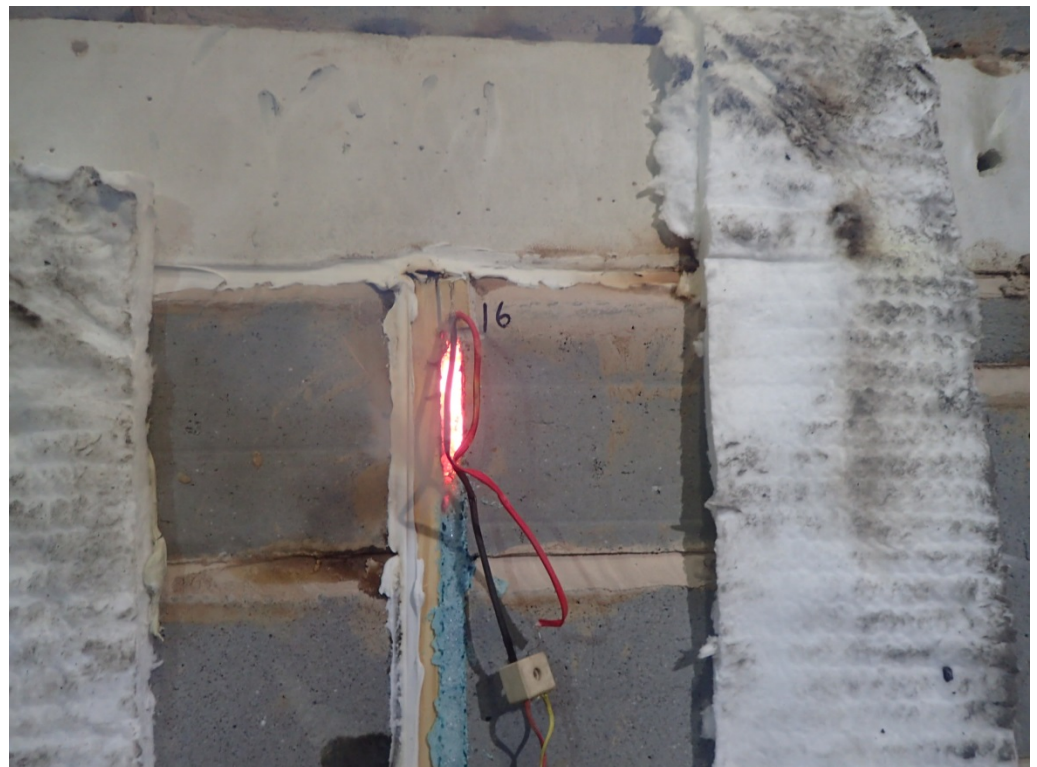
Integrity failure of
Specimen B after
a test duration of
216 minutes

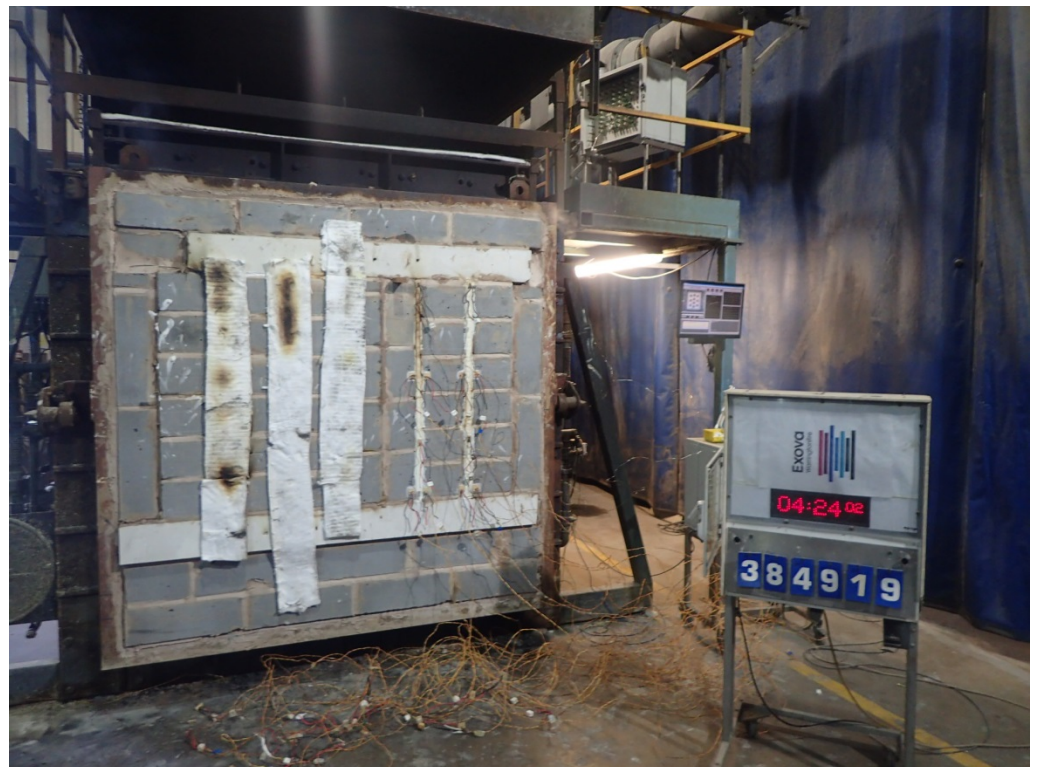
The unexposed face of the wall construction after a test duration of 264 minutes

264	00	Test discontinued.

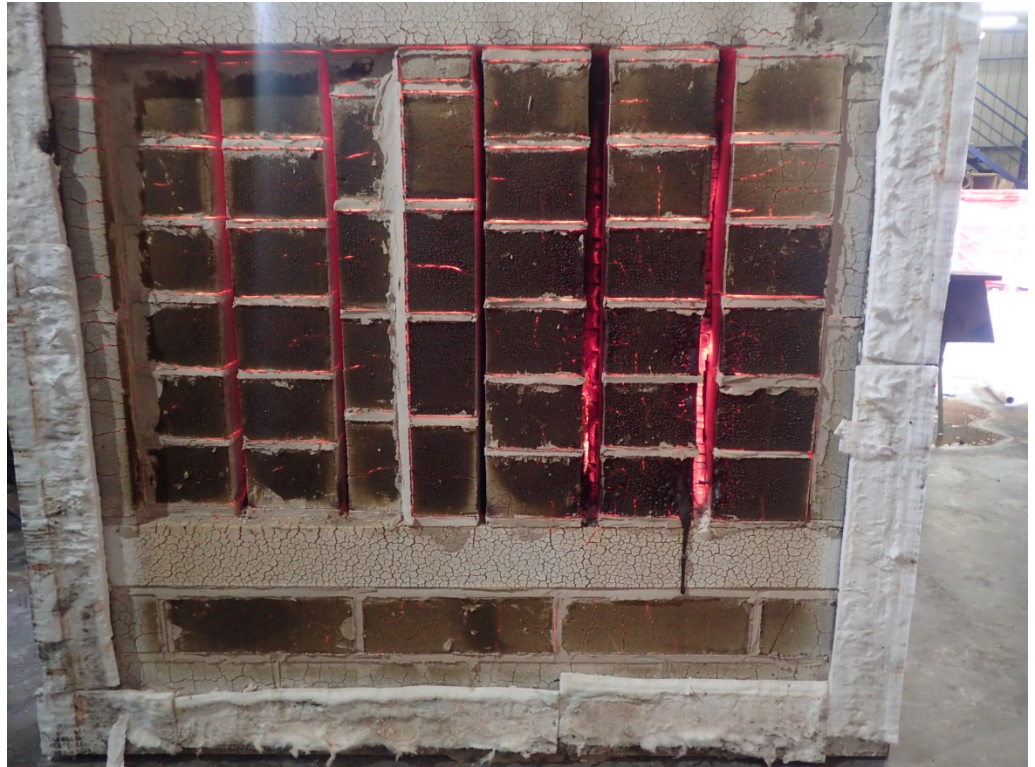
The exposed face
of the wall
construction
immediately after
the test

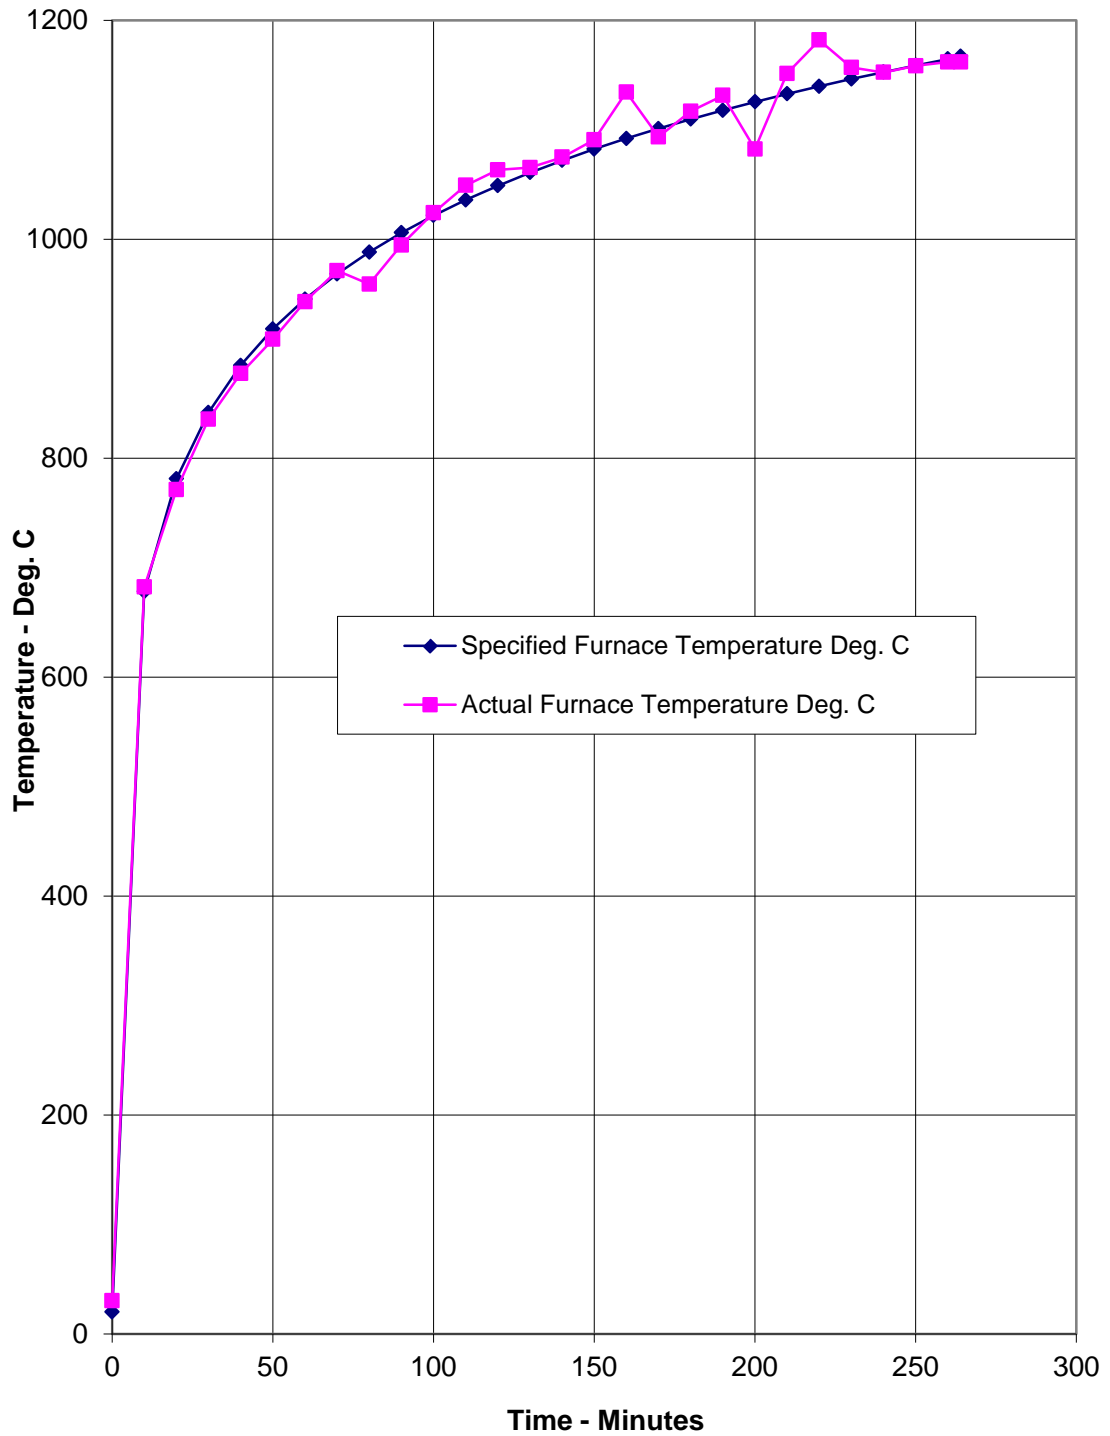
Graph Showing Mean Furnace Temperature, Together With The Temperature/Time Relationship Specified In BS EN 1363-1: 2012

Time Mins	Specified Furnace Temperature Deg. C	Actual Furnace Temperature Deg. C
0	20	30
10	678	682
20	781	771
30	842	836
40	885	877
50	918	909
60	945	943
70	968	971
80	988	959
90	1006	995
100	1022	1024
110	1036	1049
120	1049	1064
130	1061	1066
140	1072	1075
150	1082	1091
160	1092	1135
170	1101	1094
180	1110	1117
190	1118	1132
200	1126	1083
210	1133	1152
220	1140	1182
230	1146	1157
240	1153	1153
250	1159	1159
260	1165	1162
264	1167	1162
